UNITED STATES
NUCLEAR REGULATORY COMMISSION
WASHINGTON, D.C. 20555-0001

June 1, 2001

On behalf of the Commission, I am writing in response to your letter of April 13, 2001, concerning the partial loss of offsite power at the Seabrook nuclear plant on March 5, 2001, during a winter storm. Responses to your questions are enclosed.

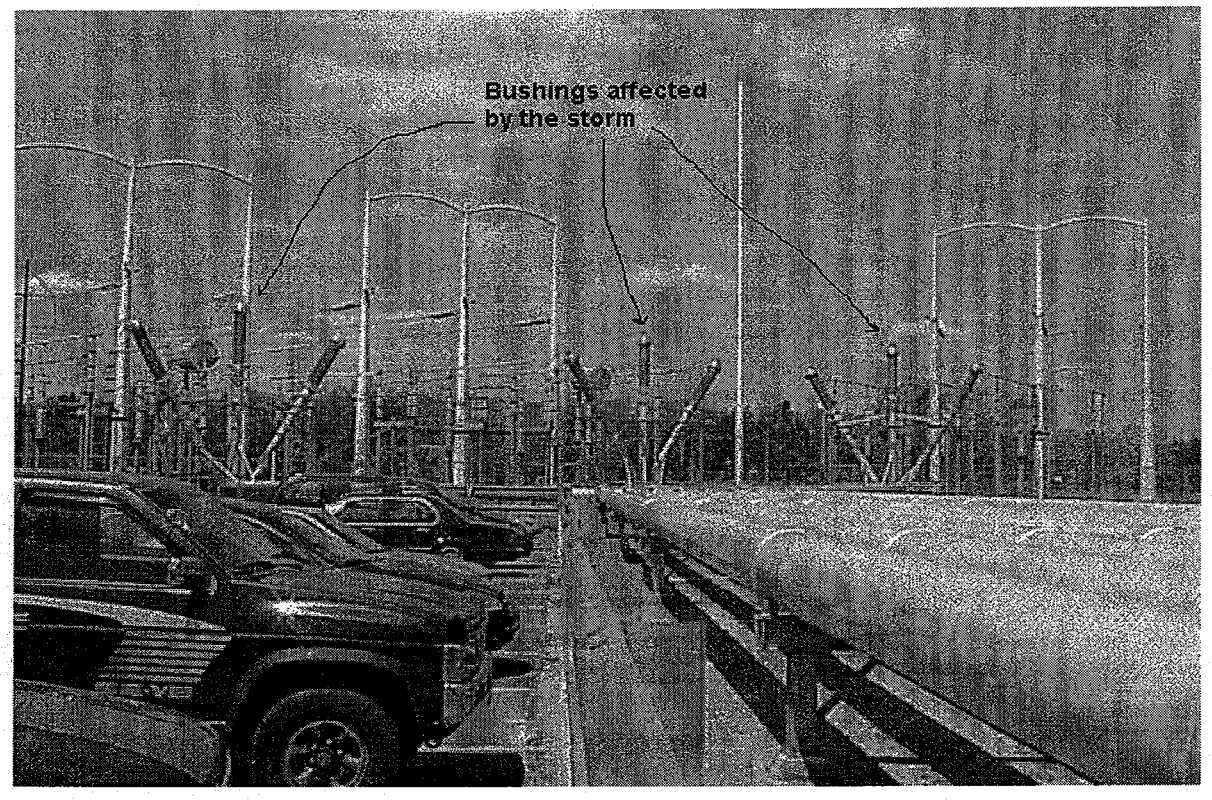
Looking away from plant toward 345kv lines

physically independent circuits be operable from the offsite transmission network to the onsite vital buses; otherwise the plant must be shut down and cooled down to a cold shutdown condition. The problem at Seabrook during this storm was arcing at the bushings in the 345 kV termination yard. The bushings provide a transition point from the overhead 345 kV lines to the insulated bus sections of the 345 kV buses. For each of the offsite 345 kV lines, two of the three phase bushings are angled and the third bushing is mounted vertically. During the March 5, 2001, storm, wet, heavy snow was driven by high winds onto the bushings. Most of the snow and ice fell off the angled bushings but adhered to the vertical bushings, eventually causing a flashover (arcing) from the line to ground.

The NRC special inspection team reviewed this previous experience. The team found that the partial loss of offsite power during March 2001 had the same cause as the 1997 event. Snow buildup on the vertical bushings for the termination yard caused a short to ground, which opened circuit breakers in the offsite power switching station. After the EDGs energized the vital buses during the event in March 2001, the operators had the ability to restore power to the vital buses from offsite power. However, the operators decided to wait until the problem with the bushings was investigated.

Based on the March 2001 event, the licensee implemented procedure changes to improve the response to flashover at the bushings during severe weather. The operating crews now have specific instructions on performing timely restoration of the circuit connections to the transmission lines. The NRC special inspection team viewed this measure as an appropriate, interim corrective action. Seabrook also entered this condition into its corrective action program to determine what, if any, long-term solutions or enhancements should be implemented. The NRC will monitor the licensee's corrective actions through the normal baseline inspection program.
