2 *WTC 1 and WTC 2*

2.1 Building Descriptions

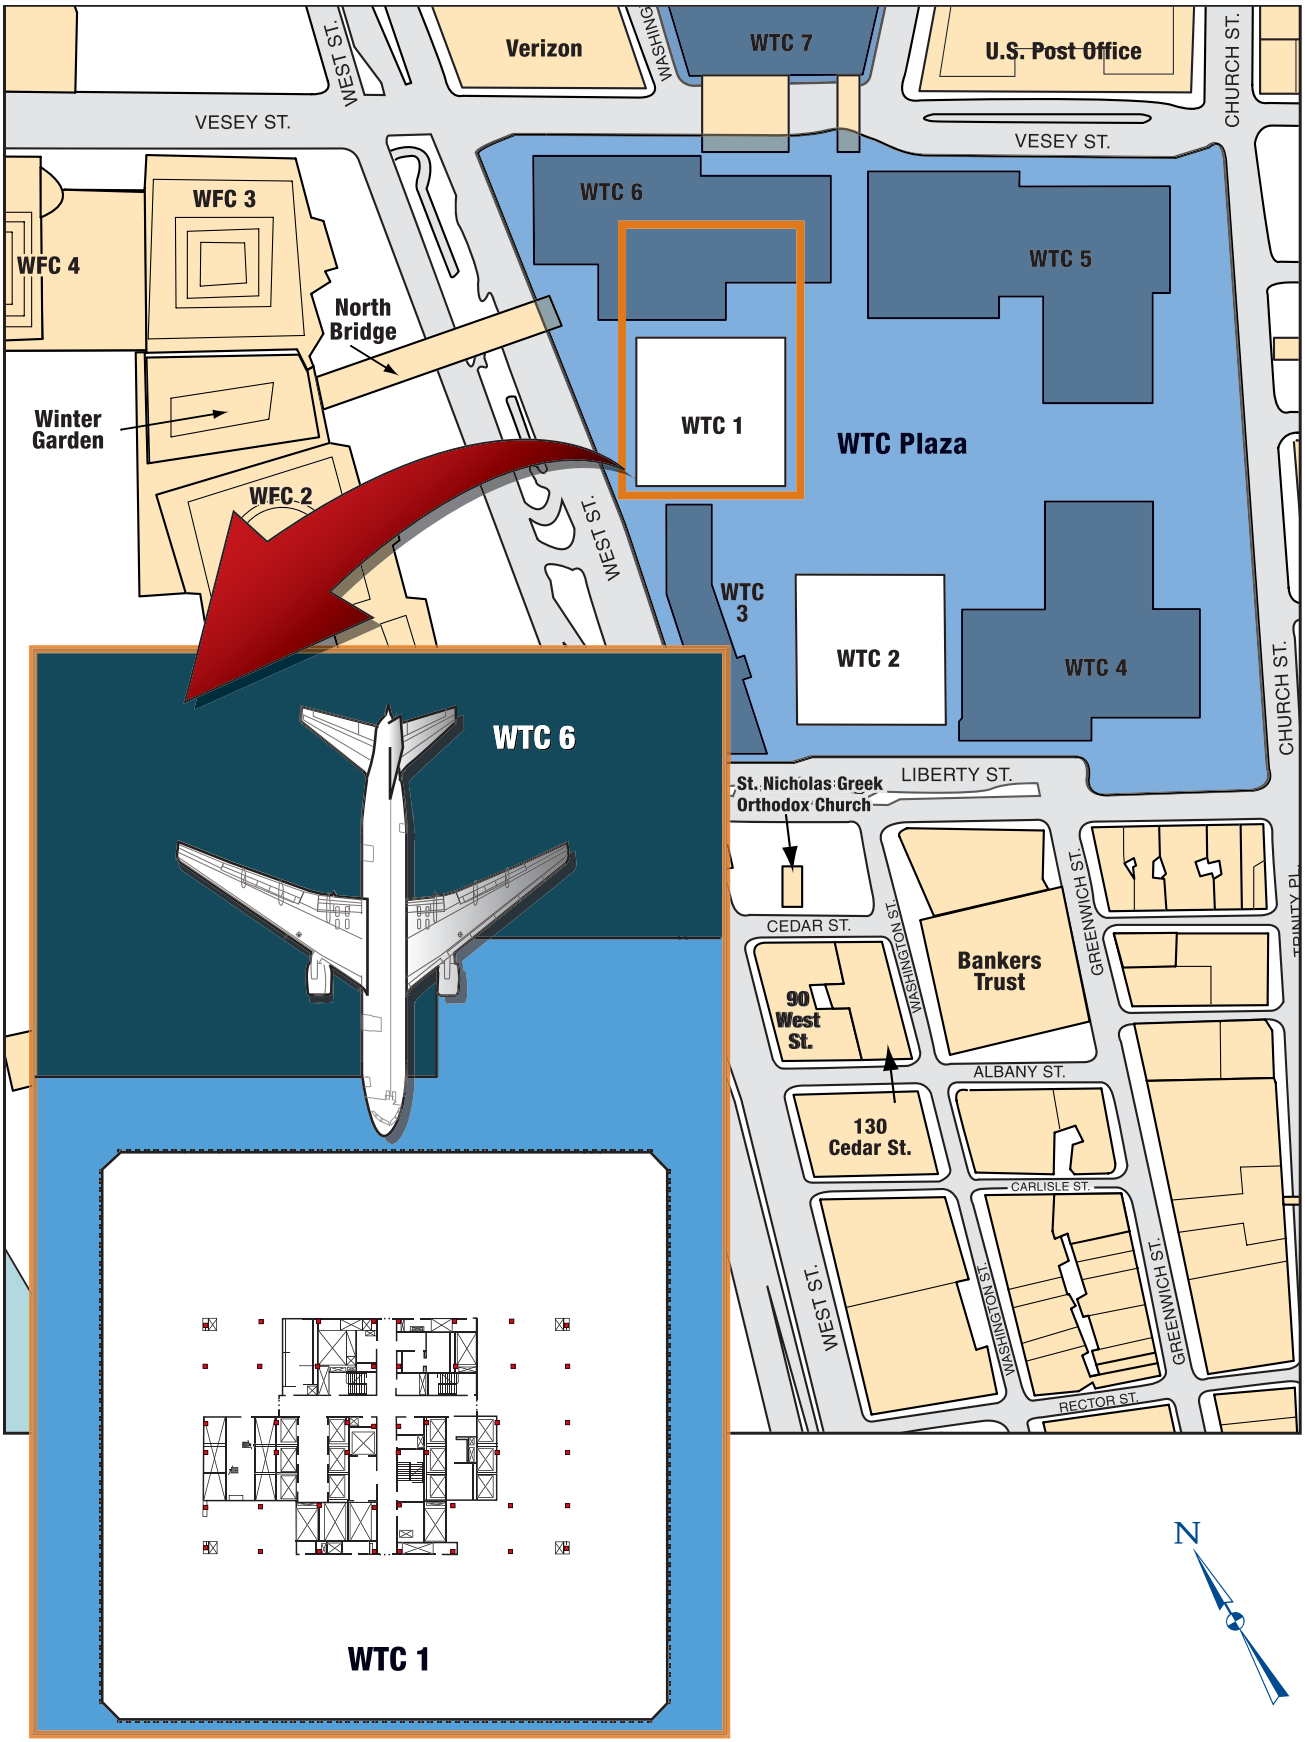
Figure 2-14 Approximate zone of impact of aircraft on the north face of WTC 1.

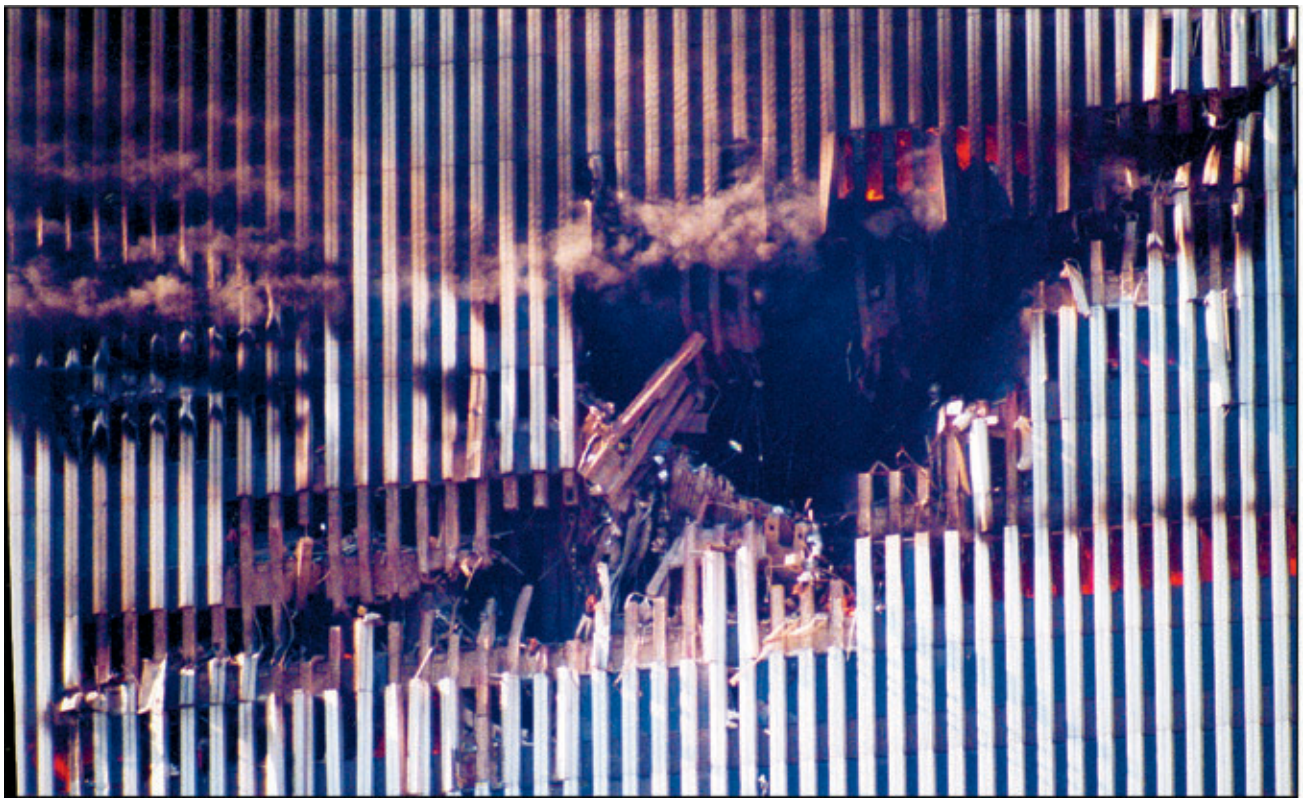
American Airlines Flight 11 struck the north face of WTC 1 approximately between the 94th and 98th floors (Figures 2-13 and 2-14), causing massive damage to the north face of the building within the immediate area (Figure 2-15). At the central zone of impact corresponding to the airplane fuselage and engines, at least five of the prefabricated, three-column sections that formed the exterior walls were broken loose of the structure, and some were pushed inside the building envelope. Locally, floors supported by these exterior wall sections appear to have partially collapsed, losing their support along the exterior wall. Away from this central zone, in areas impacted by the outer wing structures, the exterior columns were fractured by the force of the collision. Interpretation of photographic evidence suggests that from 31 to 36 columns on the north building face were destroyed over portions of a four-story range. Partial collapse of floors in this zone appear to have occurred over a horizontal length of wall of approximately 65 feet, while floors in other portions of the building appear to have remained intact. Figure 2-16 shows the damage to the exterior columns on the impacted face of WTC 1.

Figure 2-15 Impact damage to the north face of WTC 1.

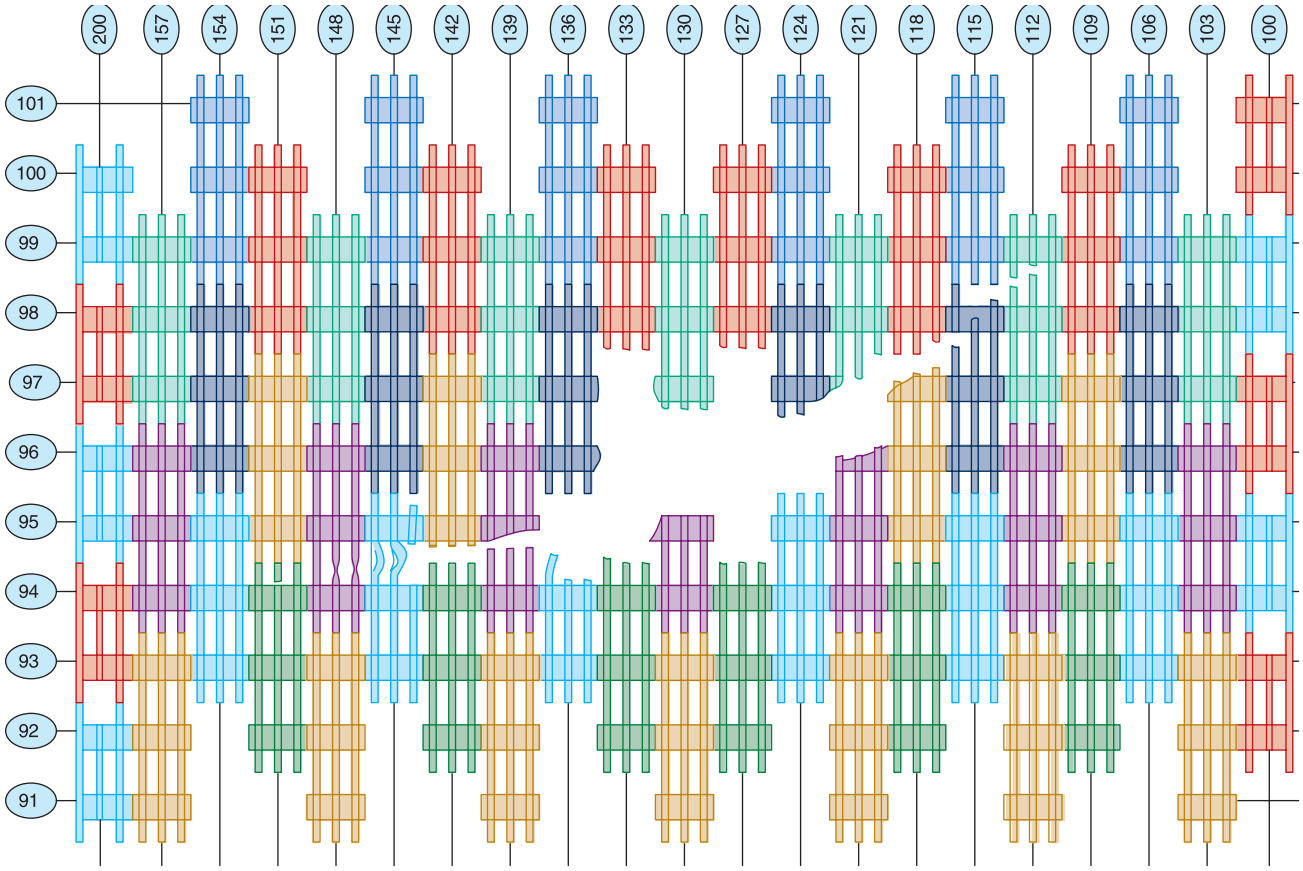
GENERAL NOTES: (1) Column damage captured from photographs and enhanced videos. (2) Damage to column lines 111-115 at level 98 is estimated.

Figure 2-16 Impact damage to exterior columns on the north face of WTC 1.

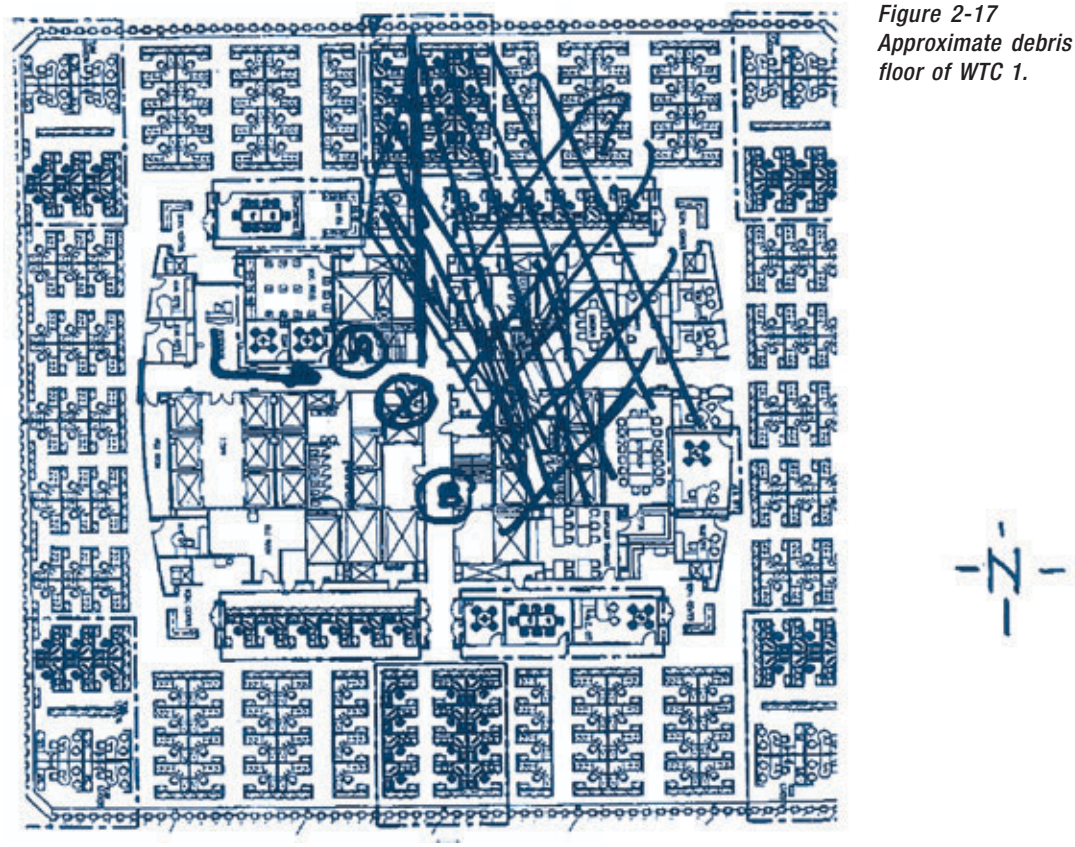
In addition to this damage at the building perimeter, a significant but undefined amount of damage also occurred to framing at the central core. Interviews were conducted with persons who were present in offices on the 91st floor of the building at the north face of the structure, three floors below the approximate zone of impact. Their descriptions of the damage evident at this floor level immediately following the aircraft impact suggest relatively slight damage at the exterior wall of the building, but progressively greater damage to the south and east. They described extensive building debris in the eastern portion of the central core, preventing their access to the easternmost exit stairway. This suggests the possibility of immediate partial collapse of framing in the central core. These persons also described the presence of debris from collapsed partition walls from upper floors in stairways located further to the west, suggesting the possibility of some structural damage in the northwestern portion of the core framing as well. Figure 2-17 is a sketch made during an interview with building occupants indicating portions of the 91st floor that could not be accessed due to accumulated debris.

Figure 2-17
Approximate debris location on the 91st floor of WTC 1.

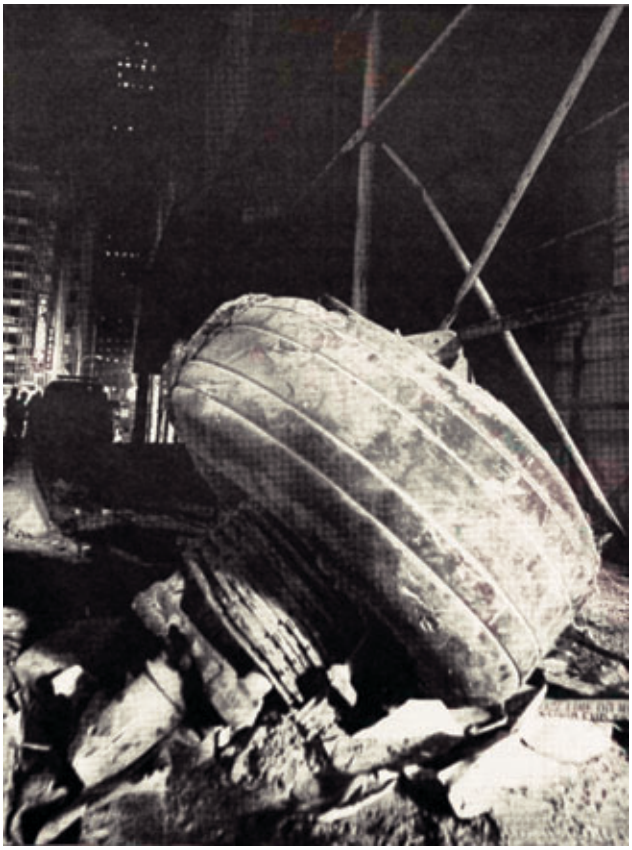
Figure 2-18
Landing gear found at the corner of West and Rector Streets.

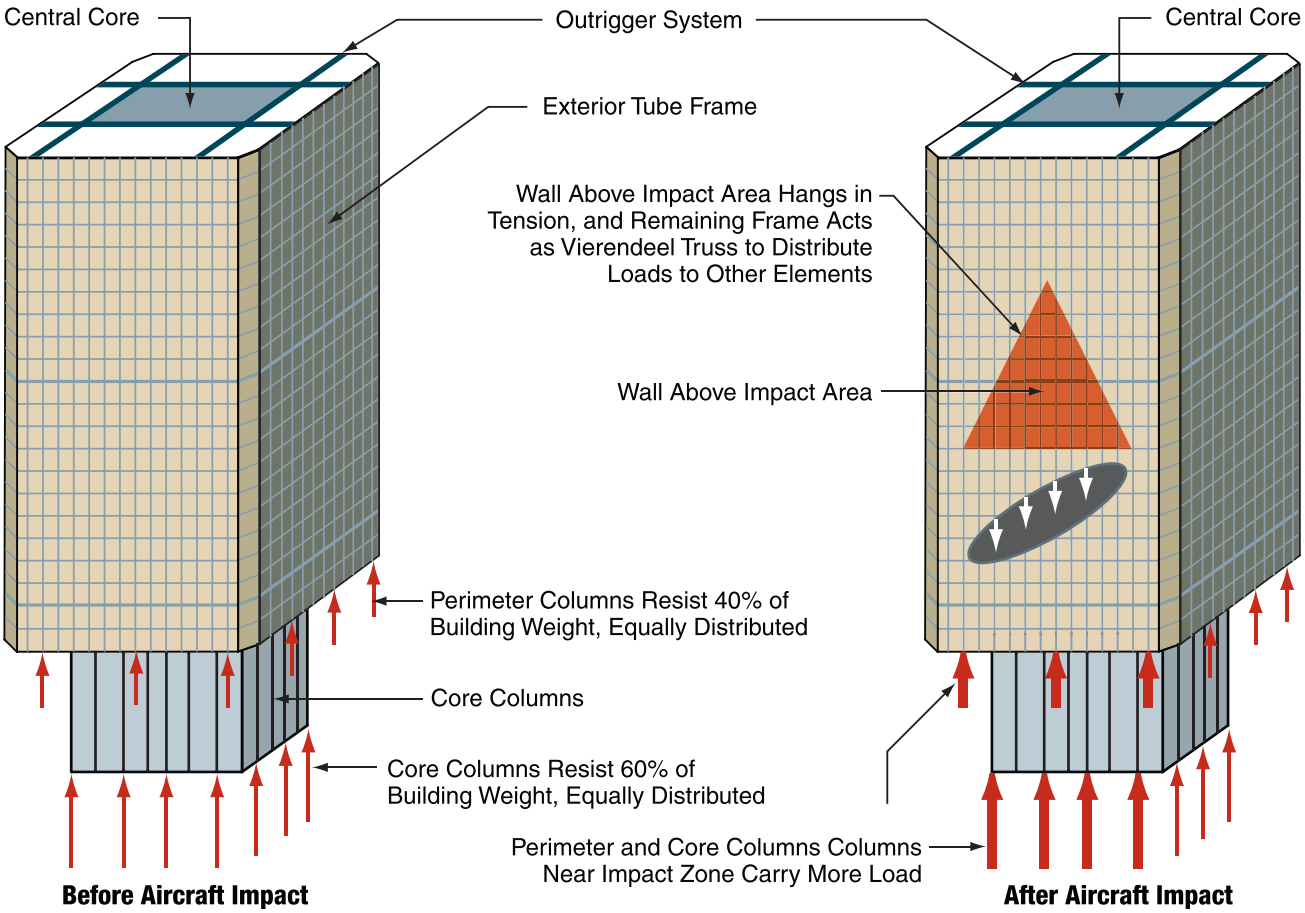
previously described. Following the impact, floor loads originally supported by the exterior columns in compression were successfully transferred to other load paths. Most of the load supported by the failed columns is believed to have transferred to adjacent perimeter columns through Vierendeel behavior of the exterior wall frame. Preliminary structural analyses of similar damage to WTC 2 suggests that axial load demands on columns immediately adjacent to the destroyed columns may have increased by as much as a factor of 6 relative to the load state prior to aircraft impact. However, these exterior columns appear to have had substantial overstrength for gravity loads.

Figure 2-19 Redistribution of load after aircraft impact.

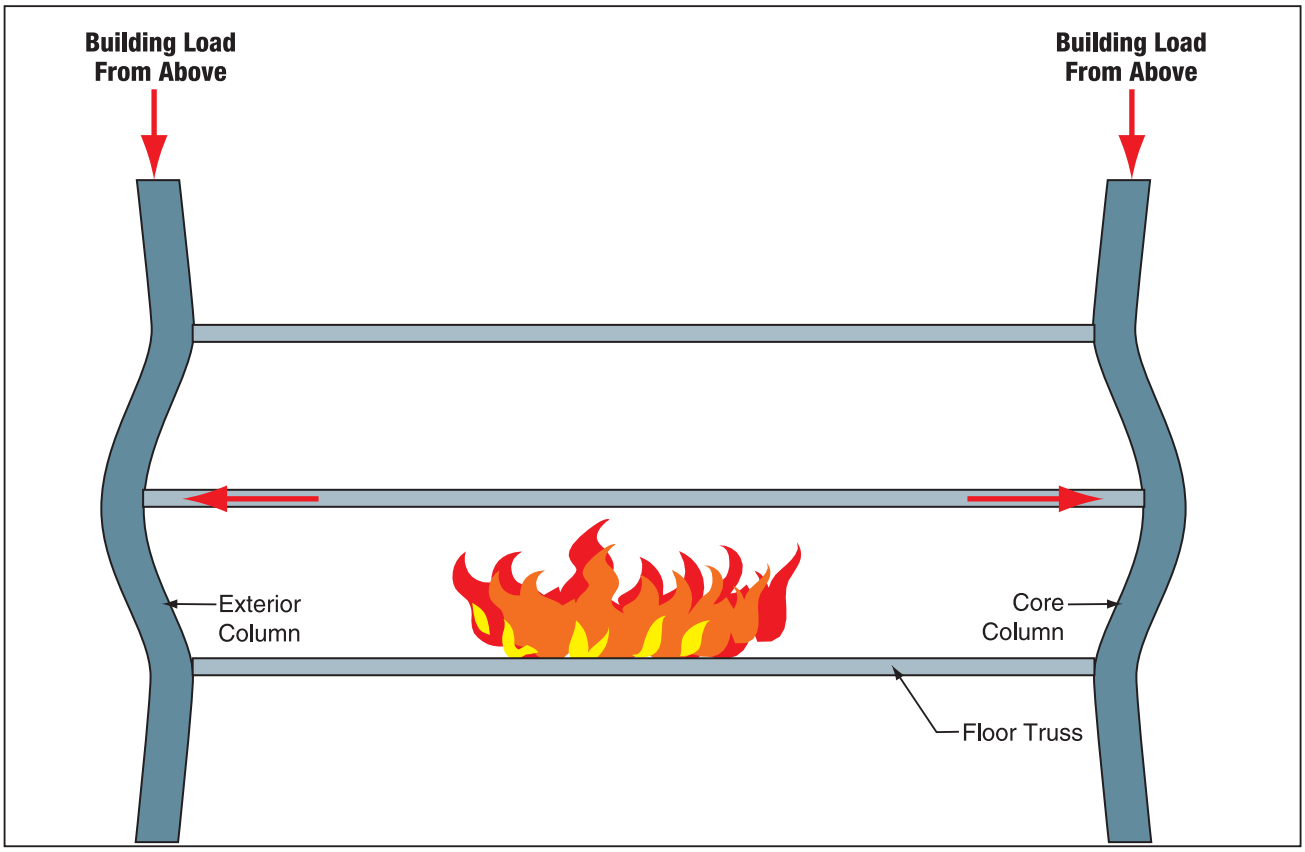
- As floor framing and supported slabs above and in a fire area are heated, they expand. As a structure expands, it can develop additional, potentially large, stresses in some elements. If the resulting stress state exceeds the capacity of some members or their connections, this can initiate a series of failures (Figure 2-20).

Figure 2-20 Expansion of floor slabs and framing results in outward deflection of columns and potential overload.

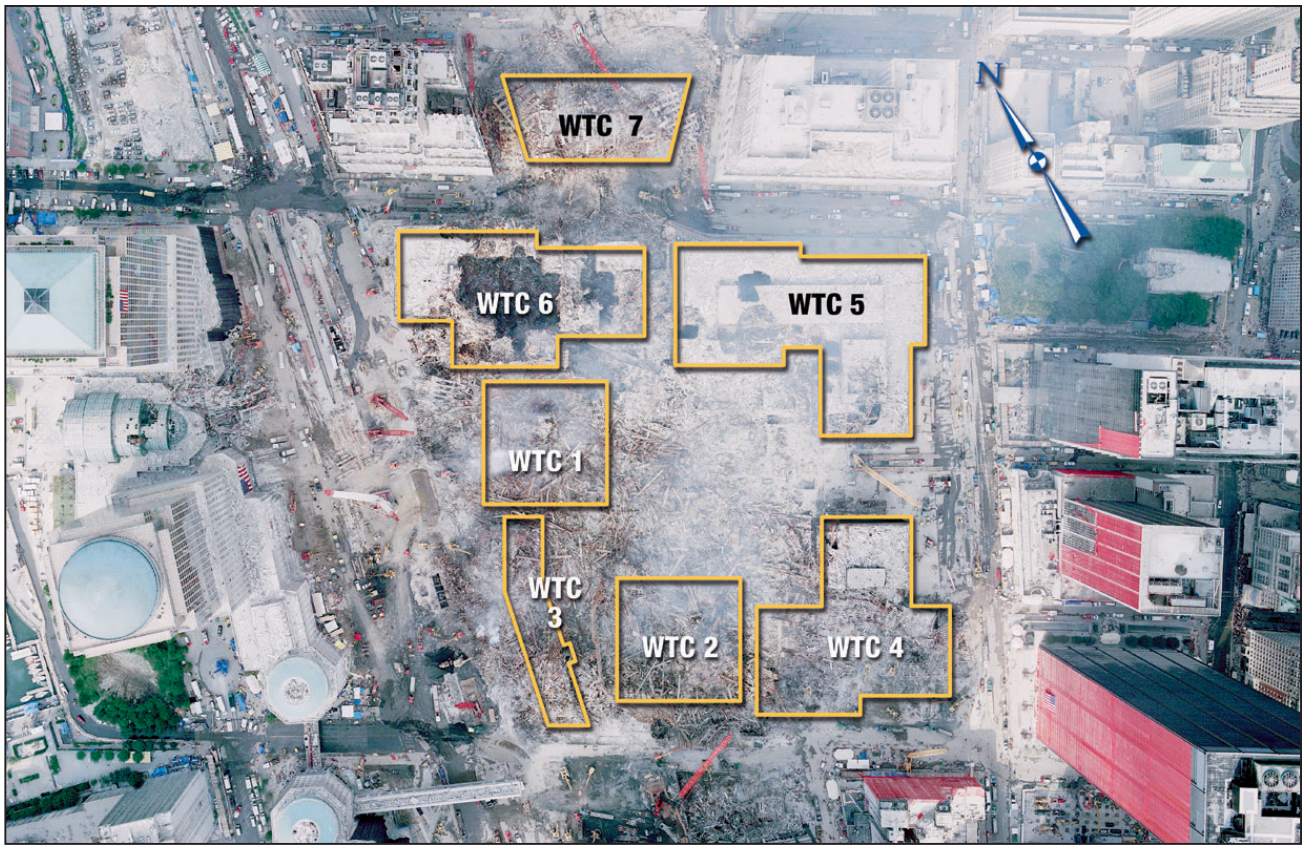
Although the building appeared to collapse within its own footprint, a review of aerial photographs of the site following the collapse, as well as damage to adjacent structures, suggests that debris impacted the Marriott Hotel (WTC 3), the Customs House (WTC 6), the Morgan Stanley building (WTC 5), WTC 7, and the American Express and Winter Garden buildings located across West Street (Figure 2-23). The debris field extended as far as 400–500 feet from the tower base.

Figure 2-23 Aerial photograph of the WTC site after September 11 attack showing adjacent buildings damaged by debris from the collapse of WTC 1.

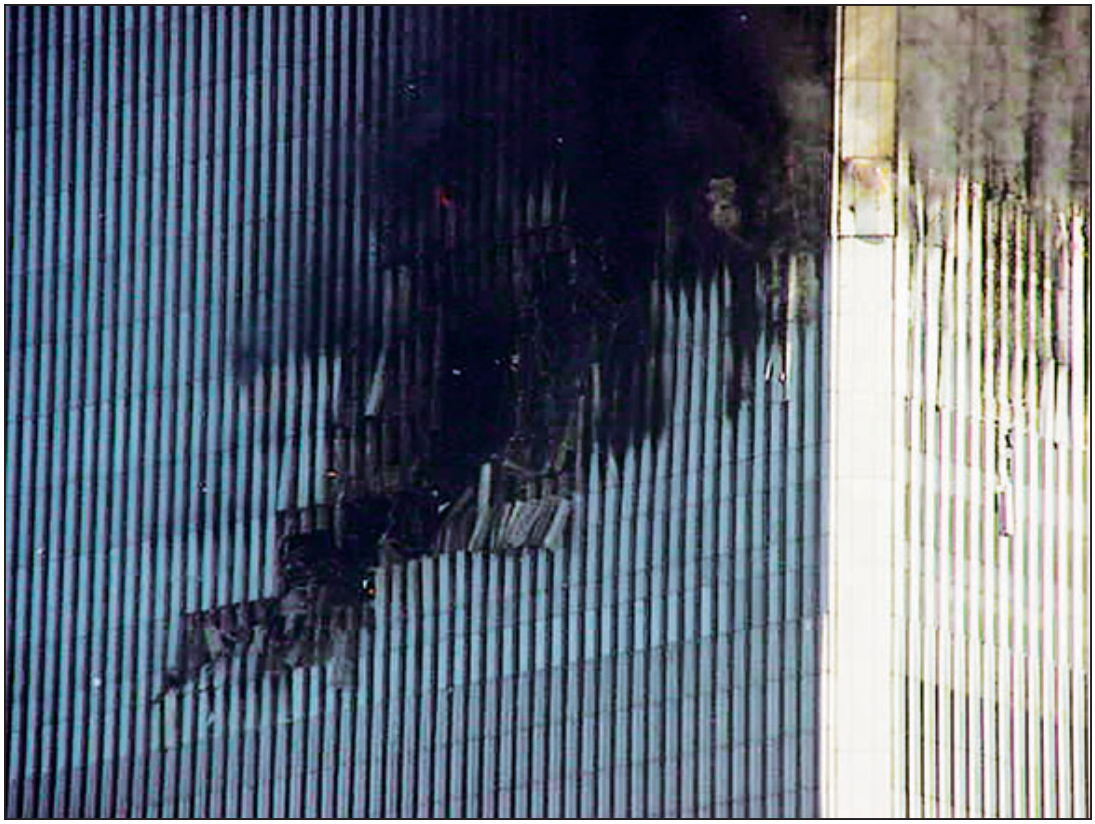
Figure 2-24 Southeast corner of WTC 2 shortly after aircraft impact.

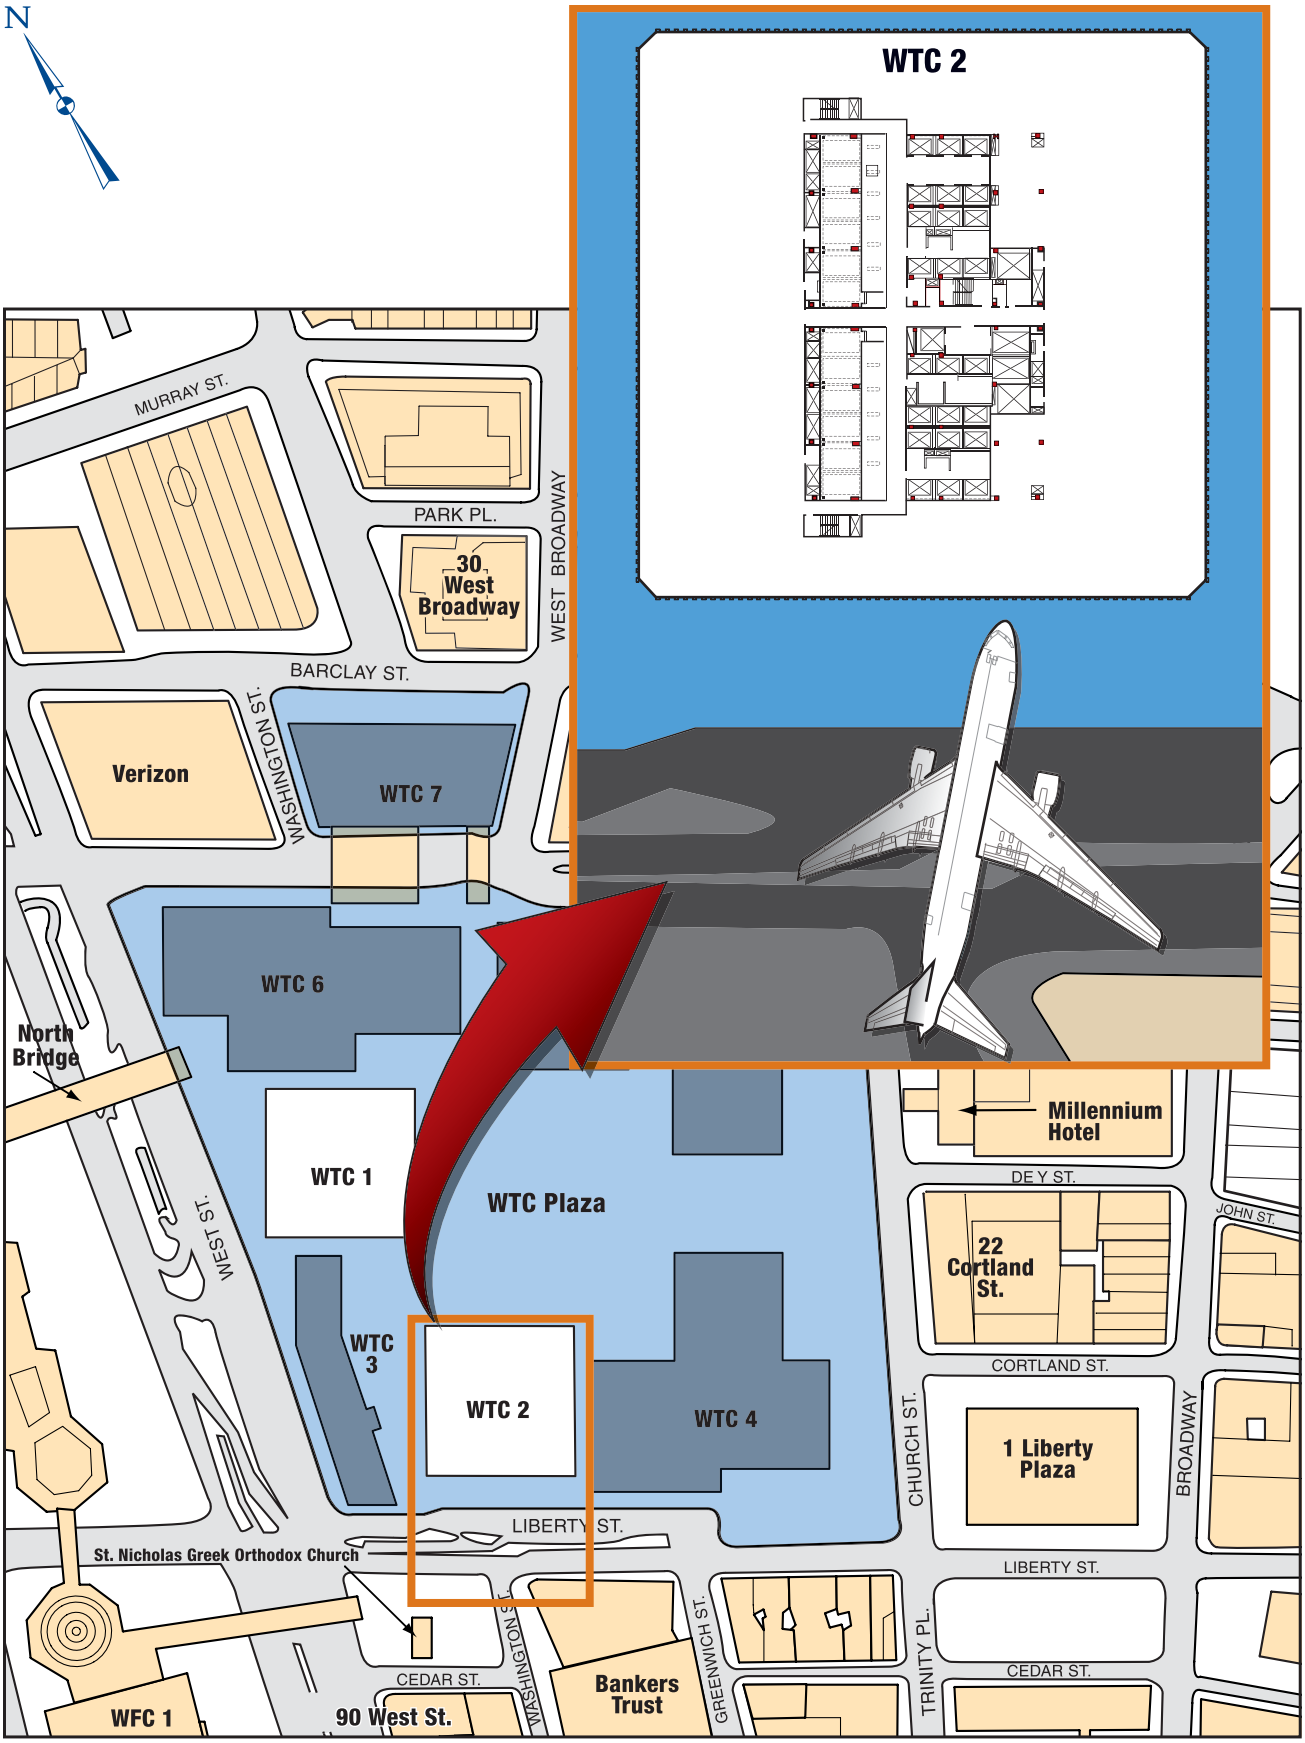
Figure 2-25 Approximate zone of impact of aircraft on the south face of WTC 2.

were fractured by the impact. Photographic evidence suggests that from 27 to 32 columns along the south building face were destroyed over a five-story range. Partial collapse of floors in this zone appears to have occurred over a horizontal length of approximately 70 feet, while floors in other portions of the building appeared to remain intact. It is probable that the columns in the southeast corner of the core also experienced some damage because they would have been in the direct travel path of the fuselage and port engine (Figure 2-25).

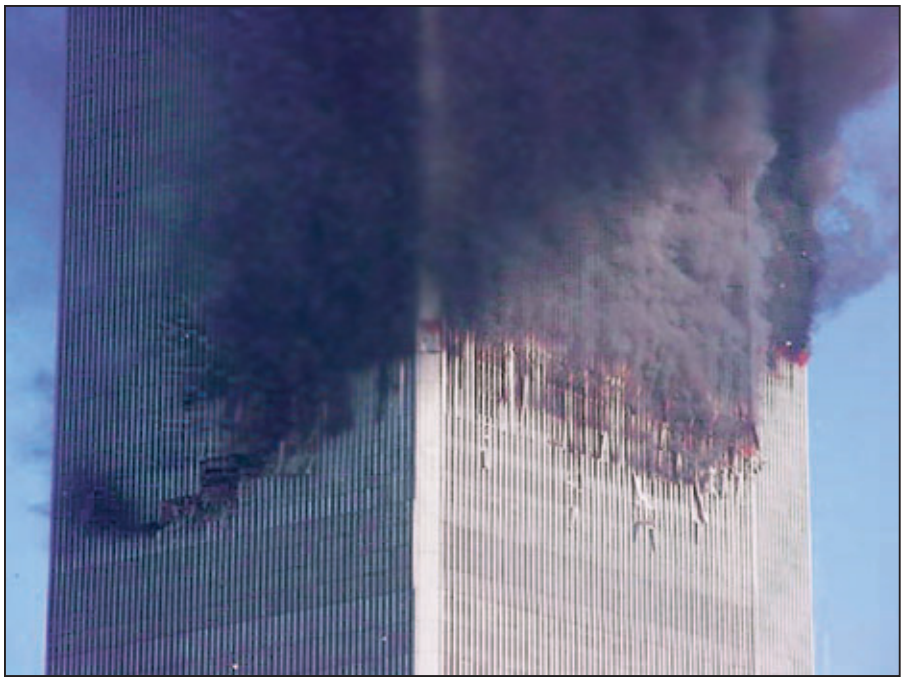
Figure 2-26
Impact damage to the south and east faces of WTC 2.

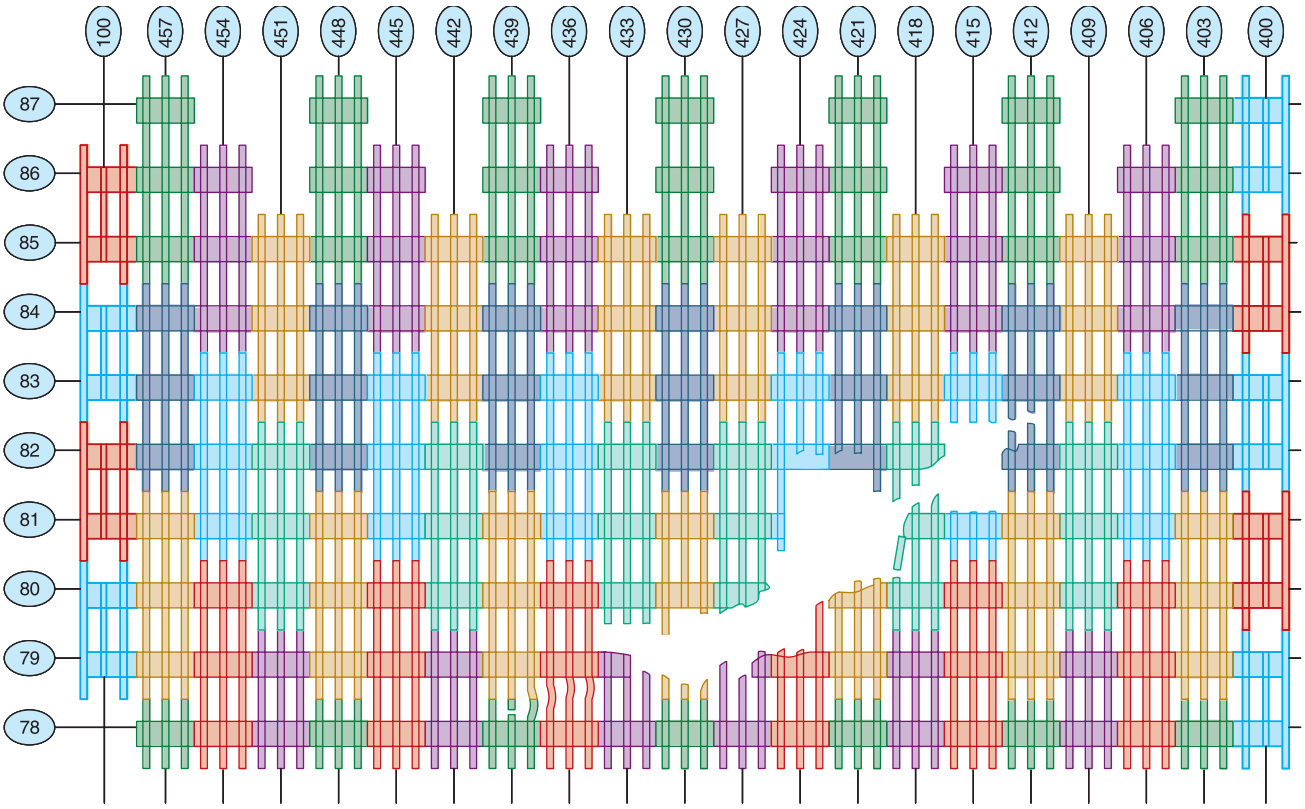
GENERAL NOTES: (1) Column damage captured from photographs and enhanced videos. (2) Damage to column lines 413-418 at levels 81 and 82 is estimated. (3) There is not sufficient information to detail damage to column lines 408-411 at levels 83-84.

Figure 2-27 Impact damage to exterior columns on the south face of WTC 2.

A second analysis was conducted to estimate the demands on columns immediately following aircraft impact and before fire effects occurred. Exterior columns were removed from the model to match the damage pattern illustrated in Figure 2-27. Although some core columns were probably damaged by the aircraft impact, the exact extent of this damage is not known and therefore was not considered in the model. As a result, this analysis is thought to underestimate the true stress state in the columns immediately after impact. The analysis indicates that most of the loads initially carried by the damaged exterior columns were transferred by Vierendeel truss action to the remaining exterior columns immediately adjacent to the impact area. If the floors at this level are assumed to remain intact and capable of providing lateral support to the columns, this raised the utilization ratio for the most heavily loaded column immediately adjacent to the damage area to approximately a value of 1.0. At a value of 1.0, columns would lose stiffness and shift load to adjacent columns. Based on this analysis, it appears that the structure had significant remaining margin

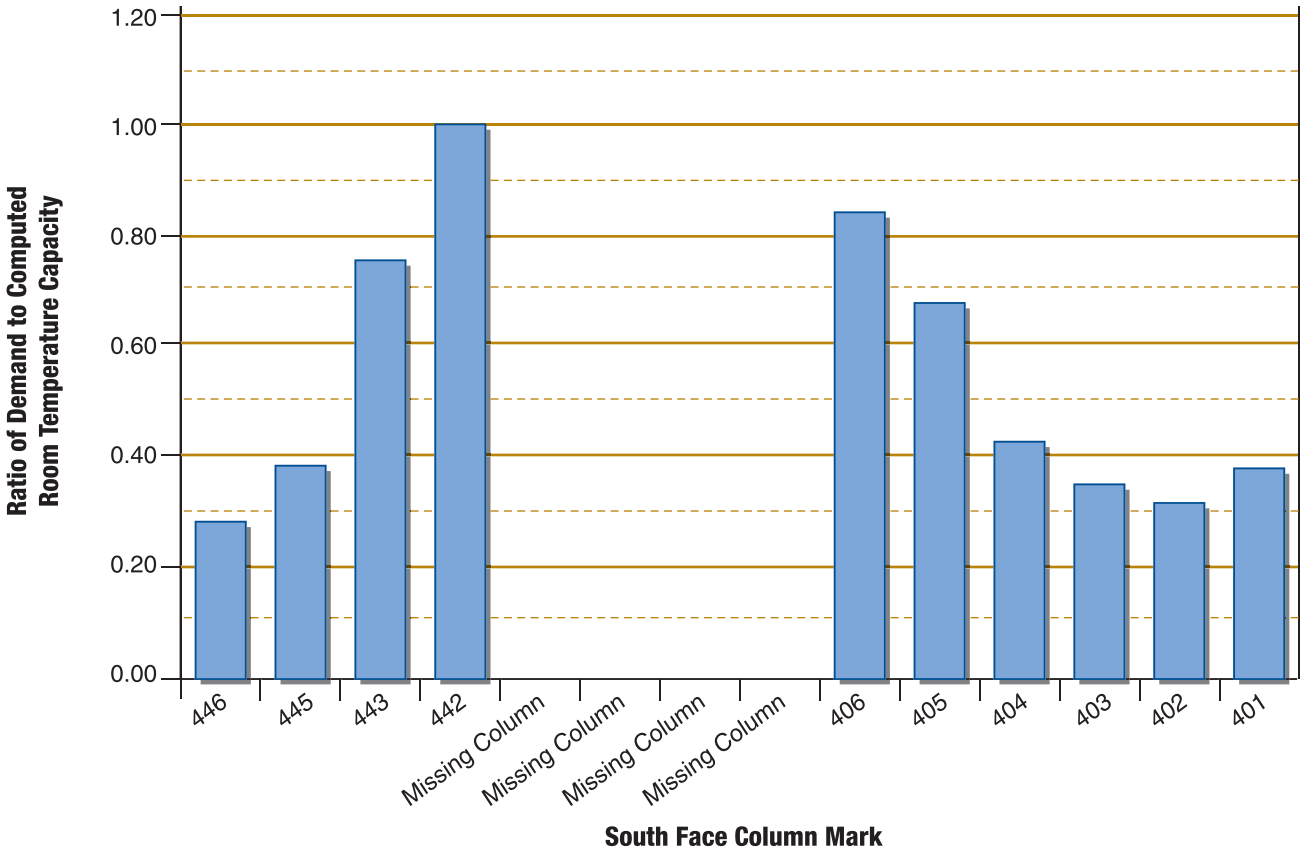
against collapse. However, this analysis does not consider damage to the building core, which was likely significant. Columns located further from the damage area are less severely impacted, and columns located only 20 feet away from the damaged area experience almost no increase in demand at all. These data are plotted in Figure 2-31.

Figure 2-31 Plot of column utilization ratio at the 80th floor of WTC 2, viewed looking outward. (Conservatively assumes columns 407–411 and 440–441 to be missing.)
